MAINTENANCE AND REPAIR RECOMMENDATIONS FOR FLAT ROOFS WATERPROOFED WITH MODIFIED BITUMEN SHEETS

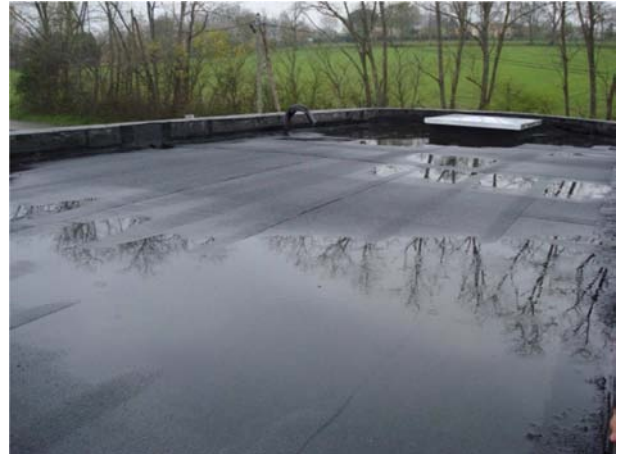
Roof on which waterlogging occurs.

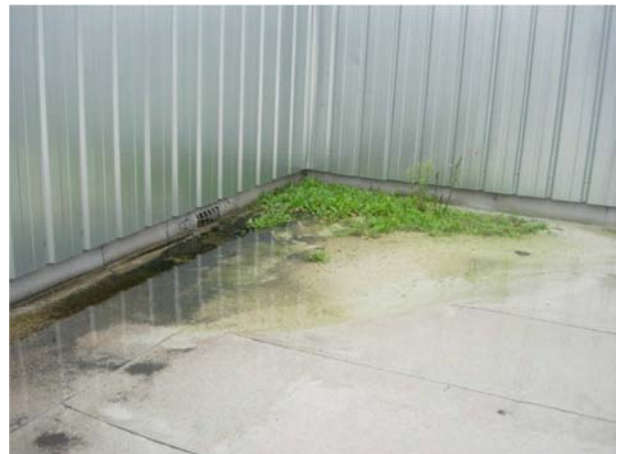
Condition of the roof in a building near areas with a lot of vegetation on which no periodic site inspections have been carried out.

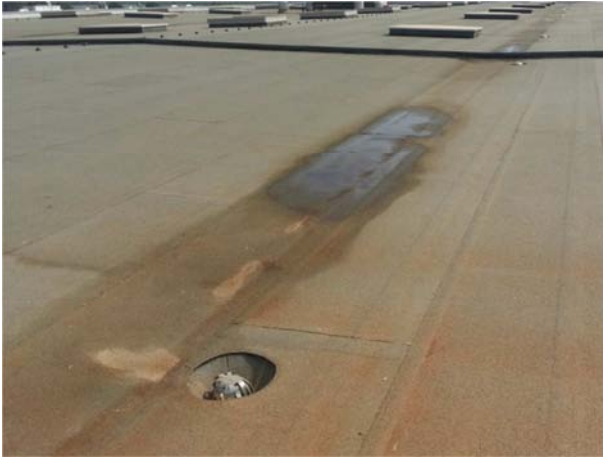
Channel with water accumulations in the vicinity of the gutters.

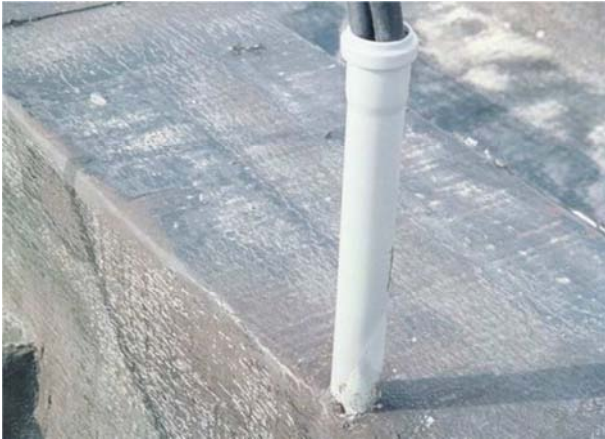
Waterproofing finish with duct channels without suitable special parts.

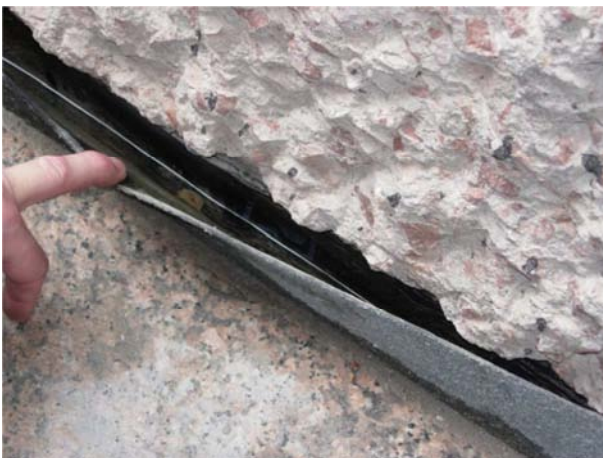
Insufficient height at the waterproofing finish against a vertical element as well as lack of adherence thereunto. Immediate corrective measures must be adopted.

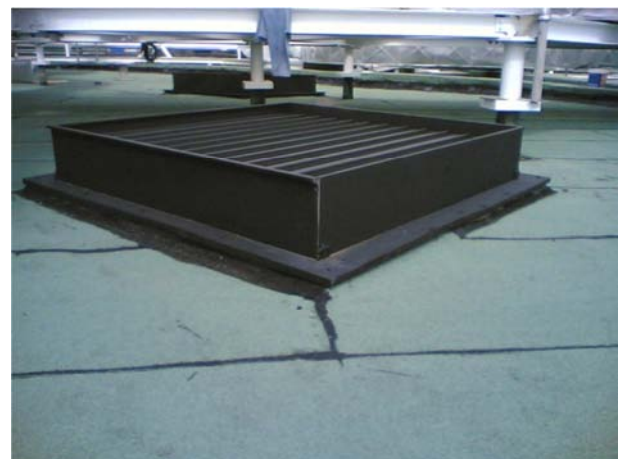
Waterproofing joint against a vent which is not very high. Immediate corrective measures must be adopted.

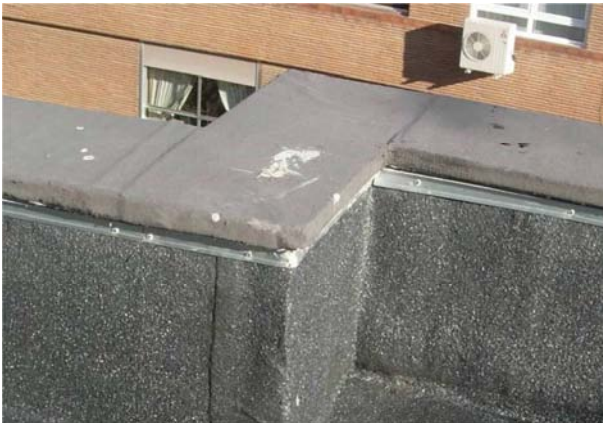
Repair using liquid systems for a coping with problems. It could also have been resolved by applying primer and subsequently welding an autoprotected sheet ESTERDAN PLUS 40/GP ELAST, ESTERDAN 40/GP POL or IMPERDAN FP 40 GP.

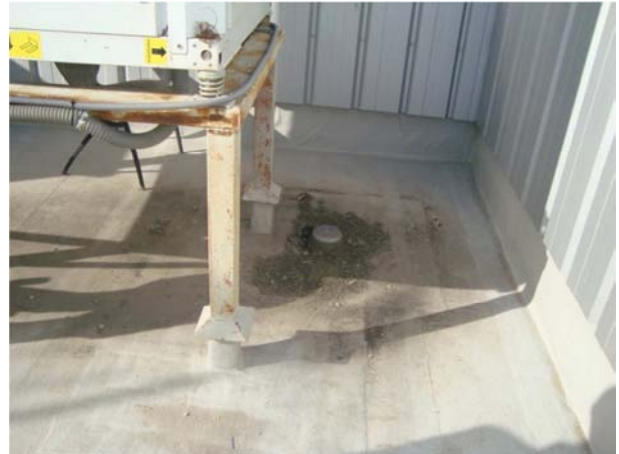
Condition of a drain on which the corresponding maintenance work has not been carried out. It must be cleaned immediately.

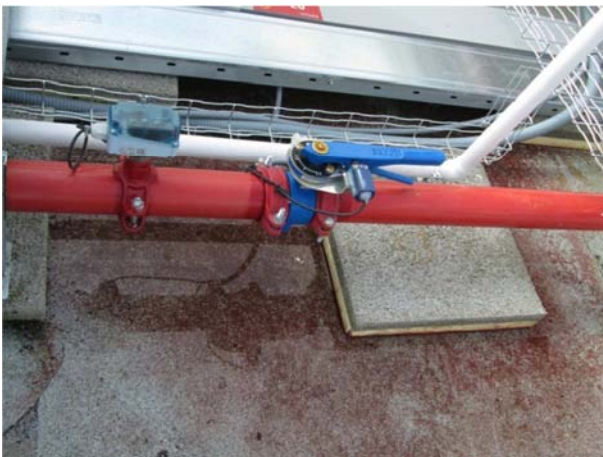
Duct support element retaining water drainage.

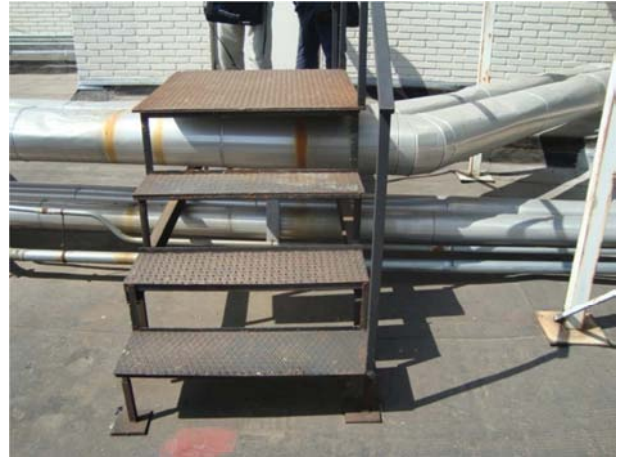
Supporting of elements on the waterproofing without any protection element. Immediate corrective actions must be adopted.

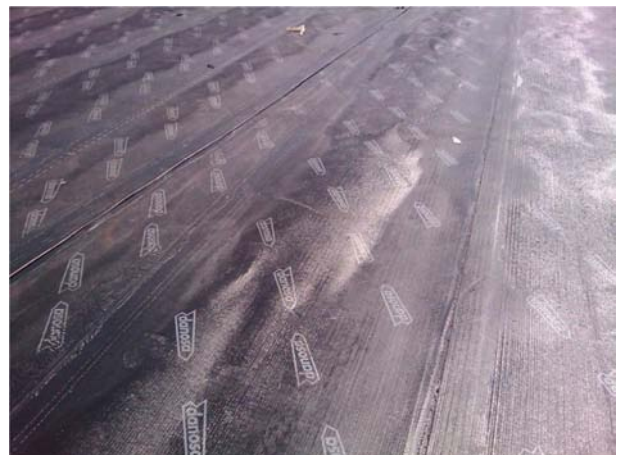
Operations to be carried out: It is not always necessary to carry out an action. It will depend on the size of the blister and its location. In the case of air pockets, their repair is recommended. Notwithstanding, an air pocket or a blister may always serve as a sign of other situations which are harmful to the roof it should always be borne in mind.

Ball bearings between the waterproofing system and the support

The solution, where necessary, will always consist of removing the blister and placing a patch on the area concerned.

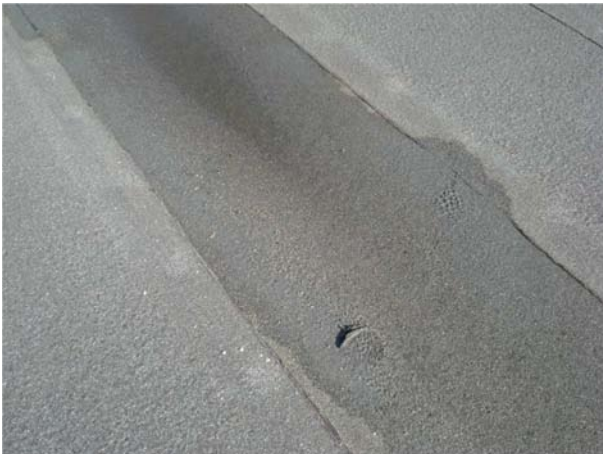
Possible origin: Loss of mineral. Loss of mineral is a habitual process on roofs. European standard EN 12.039 allows a certain mineral loss percentage. This loss in mineral may be caused by scarce maintenance of the roof, excessive traffic and the accumulation of water, sediments, deposits and dirt above the waterproofing.

Operations to be carried out: In the majority of cases the loss in mineral is a merely aesthetic aspect, under no circumstances affects the watertightness of the roof. It is only necessary to carry out periodic cleaning of the lost mineral as well as of any other type of deposit and sediment that has accumulated on the roof.

Loss of slate grain.

In the event that the deterioration can be put down to the transit of people it is necessary to restrict and limit the thoroughfare of people above it, making available technical maintenance or transit walkways

These maintenance or walkway corridors can be carried out by means of filtering slab DANOLOSA or ESTERDAN PLUS 50/GP ELAST TECHNICAL CORRIDORS in a colour different from that of the roof.

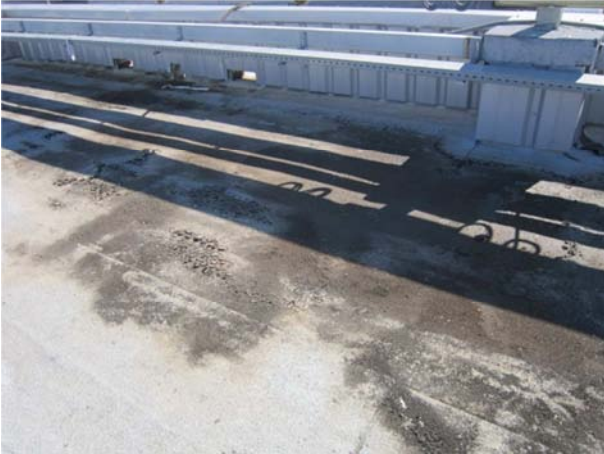
In some cases, when, owing to the effect of the water and the lack of cleaning, foreign particles are accumulated (slime, dust, leaves etc...) at the low points of the roof, the crocodile skin effect may occur. These foreign bodies form a crust above the waterproofing which, when the water evaporates, contracts and may bring about cracks in the surface. This crocodile skin effect occurs on roofs with little maintenance or poor construction and/or design of the drainage elements.

Crocodile skin effect.

To prevent sediments from accumulating on the roof it usually suffices to carry out twice-yearly maintenance works and keep the water drainage elements clean. This maintenance works will be increased on non-sloping roofs or on those on which water flooding is evident.

As a preventive measure, the water accumulation area must be treated by means of a monocomponent polyurethane fibre coating, REVESTIDAN FINISH.

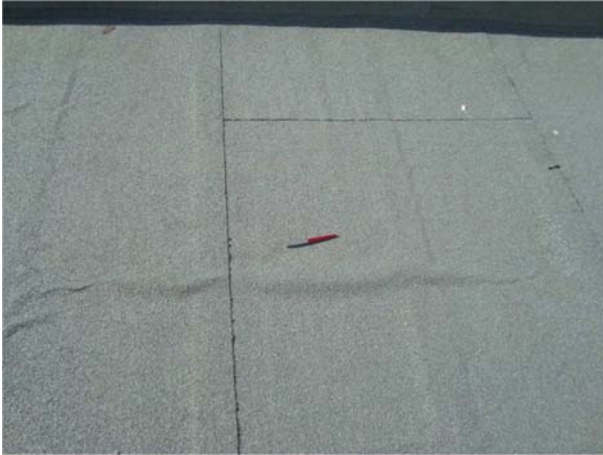
Possible origin: They are usually caused by a defect in the waterproofing system installation of the resistant support movement or of the waterproofing support movement (mortar, concrete, wood or heat insulation).

Operations to be carried out: The wrinkles usually bring about aesthetic phenomena which do not affect the watertightness of the waterproofing membrane and it is thus not always necessary to repair it.

Wrinkles perpendicular to the longitudinal direction of the roll.

In the case of wrinkles of a certain size, their elimination is recommended.

Prior to the action the cause of the wrinkle must be diagnosed. If it is a consequence of the deck

movement, opportune corrective measures must be adopted (increasing the heat insulation fixings in the area near the wrinkles if this is the cause etc...).

Once the causes generating the wrinkles have been corrected, it should be repaired.

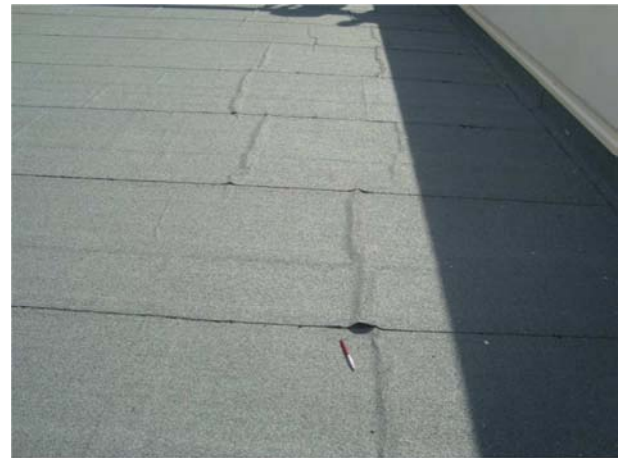
Possible origin: This is a specific case of transversal wrinkles in which the waterproofing is raised on the transversal overlap. They are usually caused by a defect in the waterproofing installation, in the resistant support movement or in the waterproofing support movement (mortar, concrete, wood or heat insulation).

Fish mouth.

Operations to be carried out: In this case it must be repaired.

Prior to the action the cause of the wrinkle must be diagnosed. If it is a consequence of the deck movement, opportune corrective measures must be adopted (increasing the heat insulation affixations in the area near the wrinkles if this is the cause etc...).

The repair procedure is that indicated above.

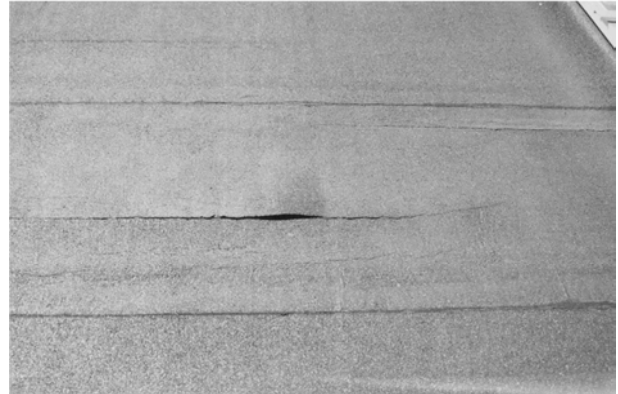
Crack in waterproofing with sheets bonded with fibreglass reinforcement.

In the event that the cracks appear in double layer waterproofing carried out using sheets with fibre glass reinforcement welded to the support, the cause may be due to the fact that a working joint of the support is transmitting stresses to the waterproofing system. Should this be the case, the repair solution may be very complicated and rewaterproofing may be required.

Operations to be carried out: This type of phenomenon requires repair as it may entail the immediate entry of water into the building.

Prior to the repair the cause of the crack must be diagnosed.

In the event of minor movements in the crack, the treatment may be carried out with an upper reinforcement band.

1. The area of the waterproofing is prepared where the reinforcement band is to be welded. This can be carried out by soaking the slate grain of the sheet in the mastic with the hot joint tool with a width at least 25 cm greater than the outer edge of the crack. Instead of soaking the slate grain, a MAXDAN bituminous emulsion may be applied to the area to be prepared. The mineral is not soaked or the autoprotected sheet not primed for the 5 cm adjoining each side of the crack.

2. The waterproofing layer is welded with a blowlamp in the pre-treated area. A waterproofing layer is welded with a blowlamp to the sheet area where the mineral has been soaked or primed (25 cm greater than the edge of the wrinkle), leaving the 5 cm adjoining the crack unwelded. In the event that the waterproofing is made of elastomer bitumen, the reinforcement band to be welded is carried out using the ESTERDAN PLUS 50/GP ELAST sheet. In the event that the waterproofing is made of plastomer bitumen of the POL range, the reinforcement band to be welded is carried out using the ESTERDAN 50/GP POL sheet.

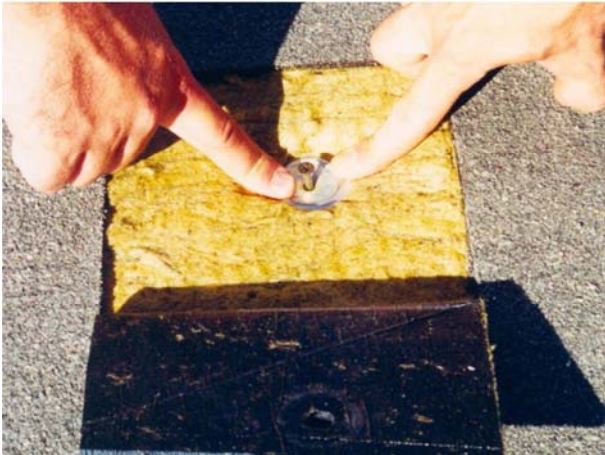
Possible origin: Use to affix the insulation or the waterproofing with unsuitable fixings.

Inappropriate affixation that has brought about the puncturing of the waterproofing system.

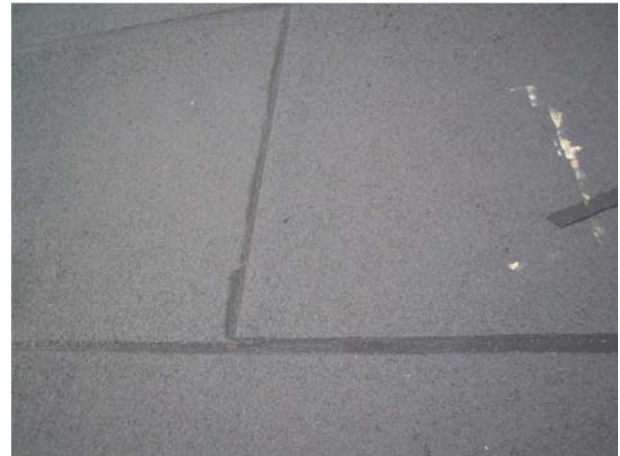
Longitudinal and transversal overlap retraction.

In the case of minor retractions, heat can be provided to the retraction area and the slate grain sprinkled.
